**JOHNSON CONTROLS, INC.
FOWLERVILLE, MI
EPA ID NO. MID099124299**

**FIELD OVERSIGHT REPORT
FOR PHASE III RFI FIELD ACTIVITIES**

FIELD OVERSIGHT REPORT
FOR PHASE III RFI FIELD ACTIVITIES

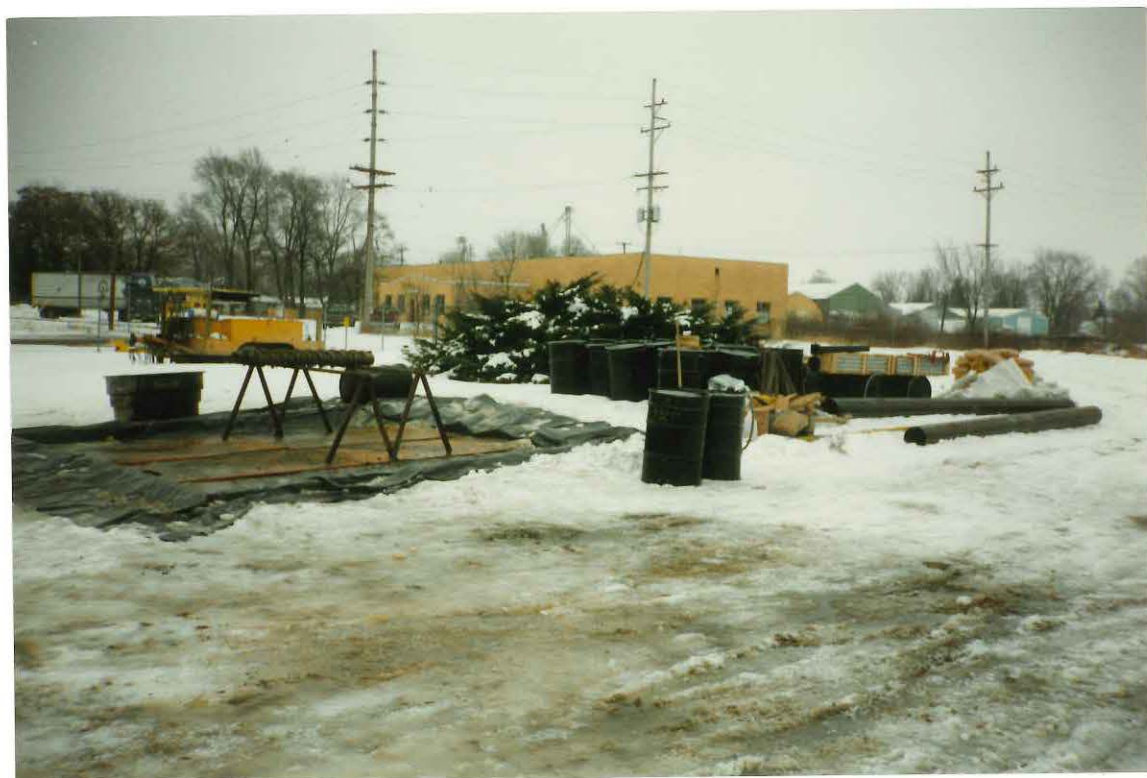
PHOTOGRAPH #20

LOCATION:	Stanley Tools, Fowlerville, MI
DATE:	1/12/94
TIME:	1300
SUBJECT:	Decon pad and equipment staging area

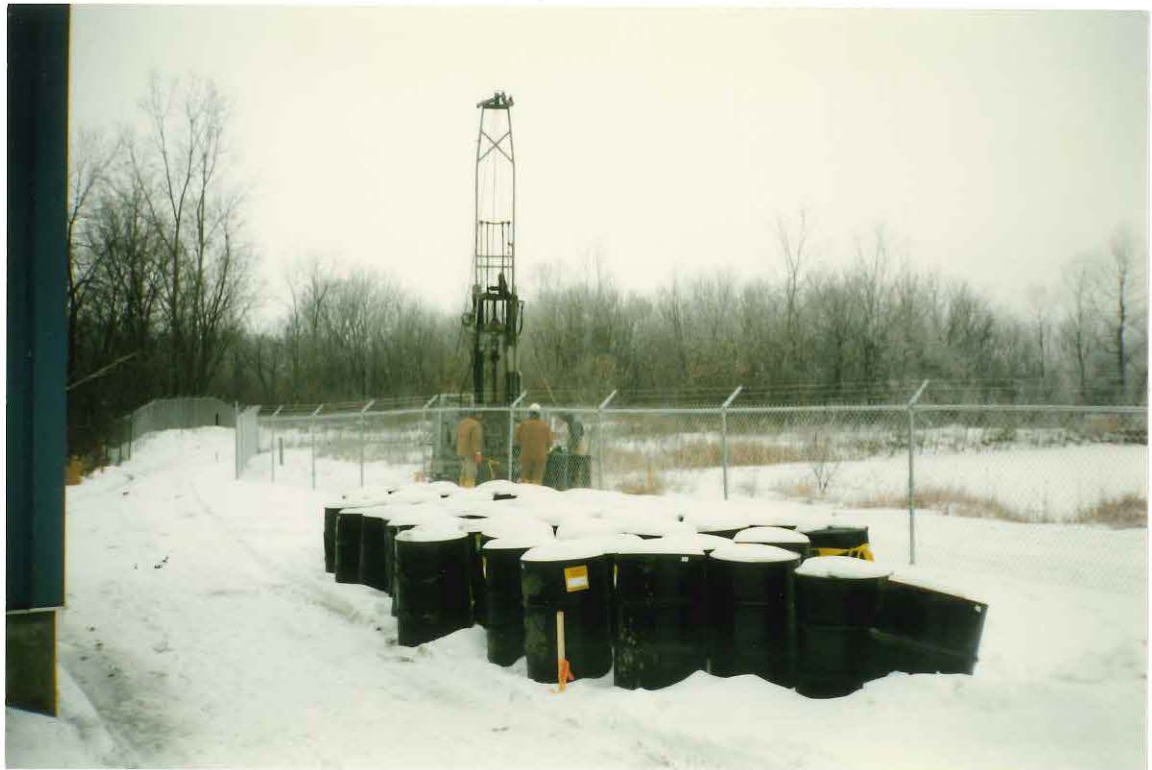
PHOTOGRAPH #21

LOCATION:	Stanley Tools, Fowlerville, MI
DATE:	1/12/94
TIME:	1320
SUBJECT:	Setting shallow well MW-E3

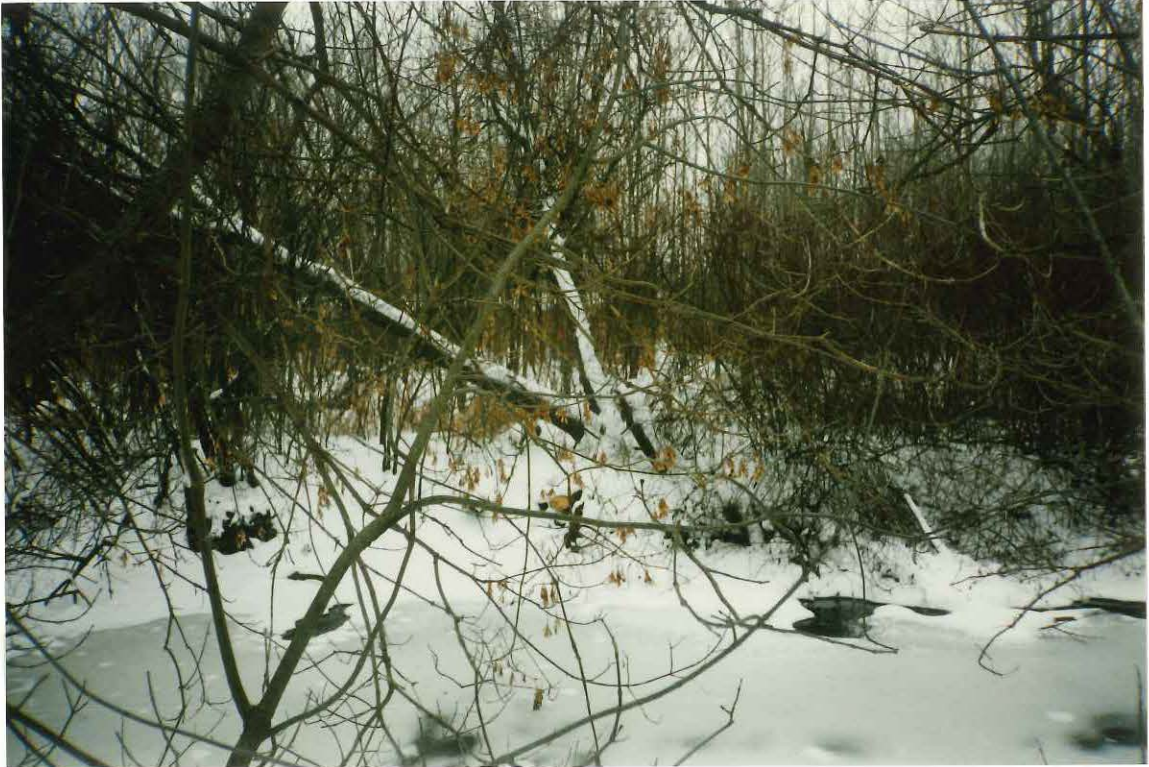
PHOTOGRAPH #23

LOCATION:	Stanley Tools, Fowlerville, MI
DATE:	1/12/94
TIME:	1340
SUBJECT:	Location of offsite well MW-OS1

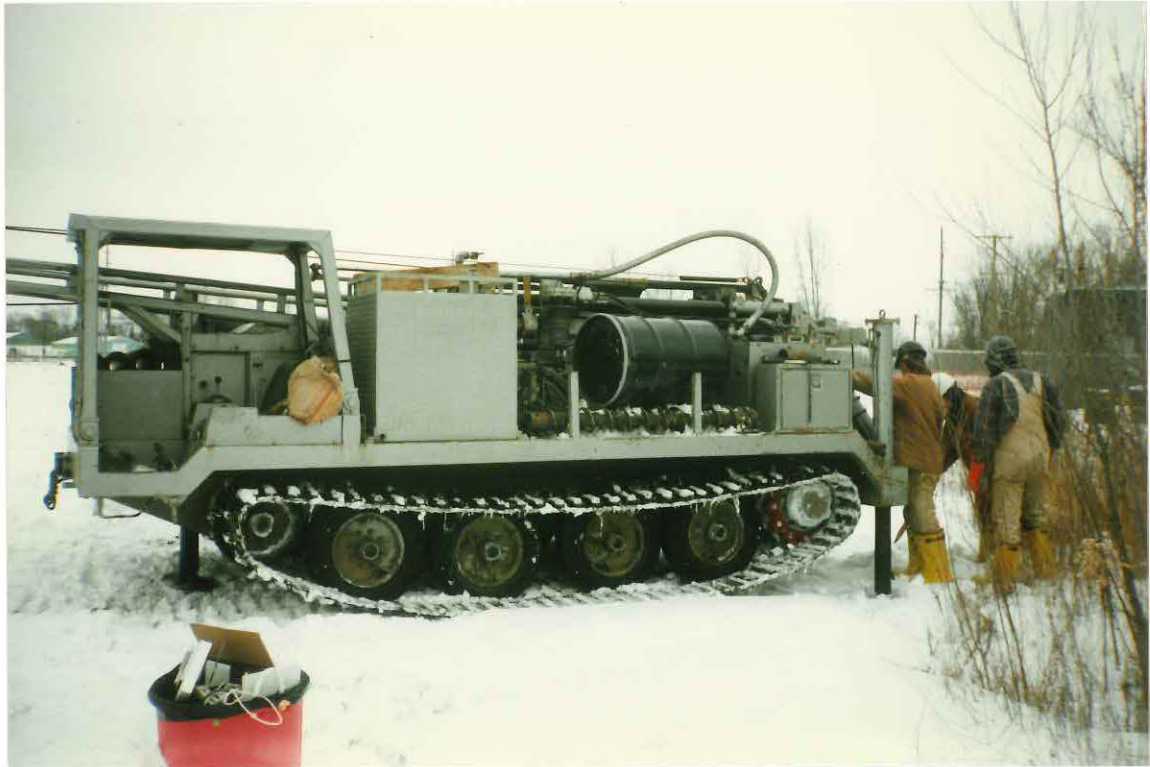
PHOTOGRAPH #24

LOCATION:	Stanley Tools, Fowlerville, MI
DATE:	1/12/94
TIME:	1527
SUBJECT:	Rig setting up on grid boring location GB-64

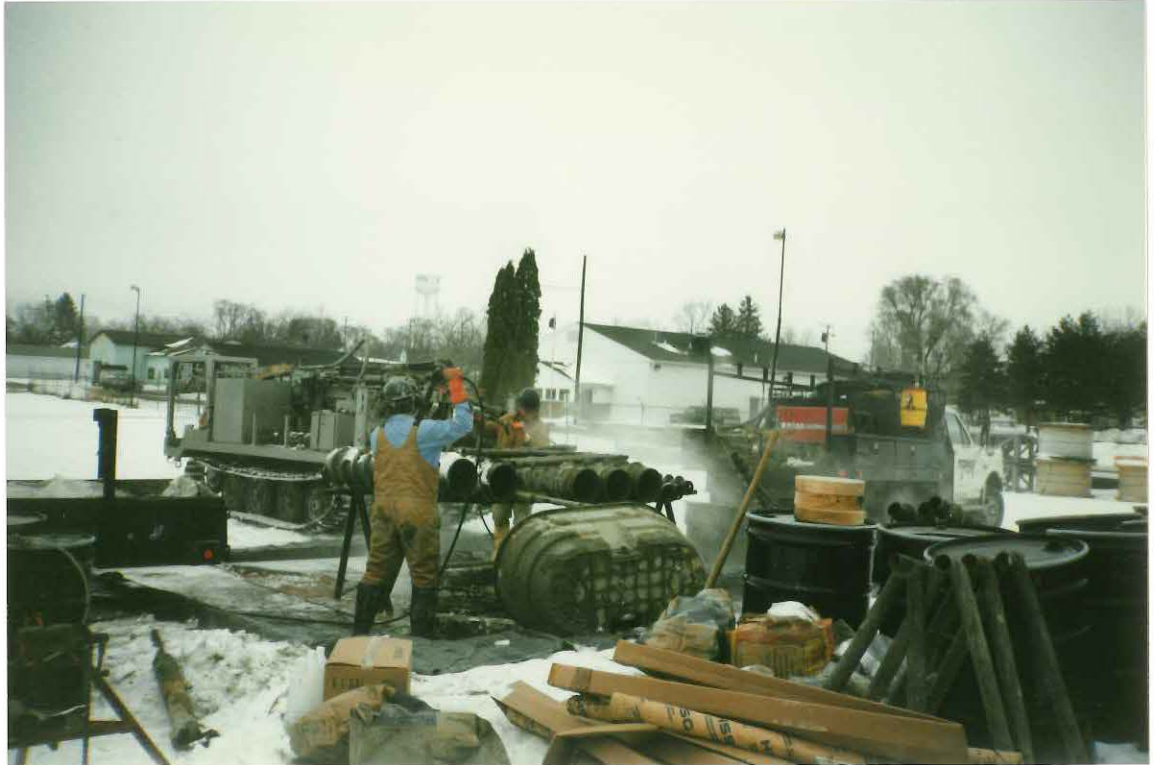
PHOTOGRAPH #25

LOCATION:	Stanley Tools, Fowlerville, MI
DATE:	1/12/94
TIME:	1615
SUBJECT:	Decon

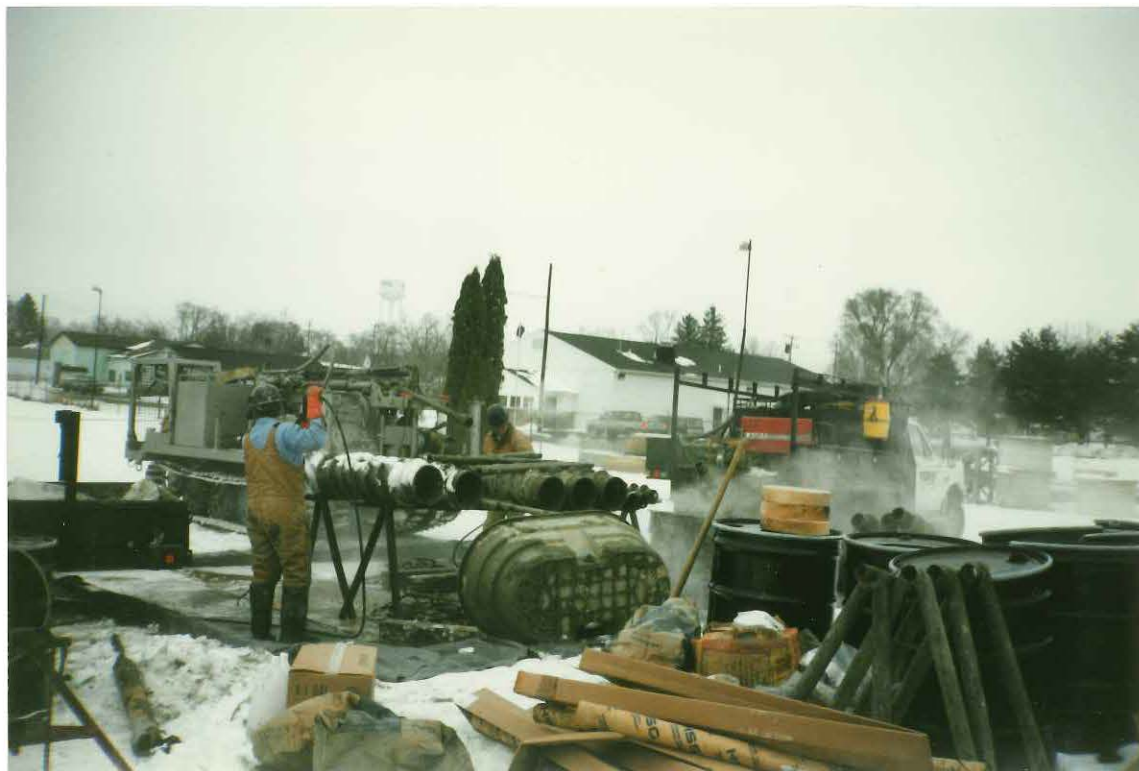
PHOTOGRAPH #26

LOCATION:	Stanley Tools, Fowlerville, MI
DATE:	1/12/94
TIME:	1615
SUBJECT:	Decon

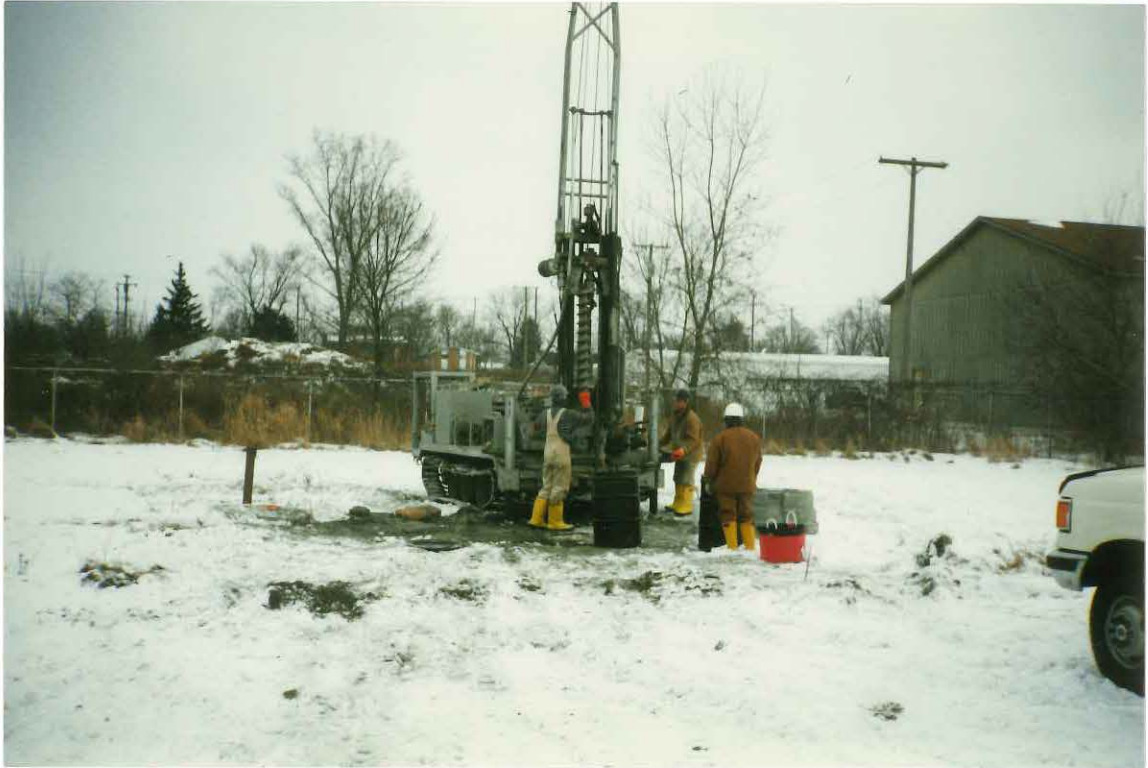
PHOTOGRAPH #27

LOCATION:	Stanley Tools, Fowlerville, MI
DATE:	1/13/94
TIME:	0846
SUBJECT:	Drilling MW-Background - shallow well

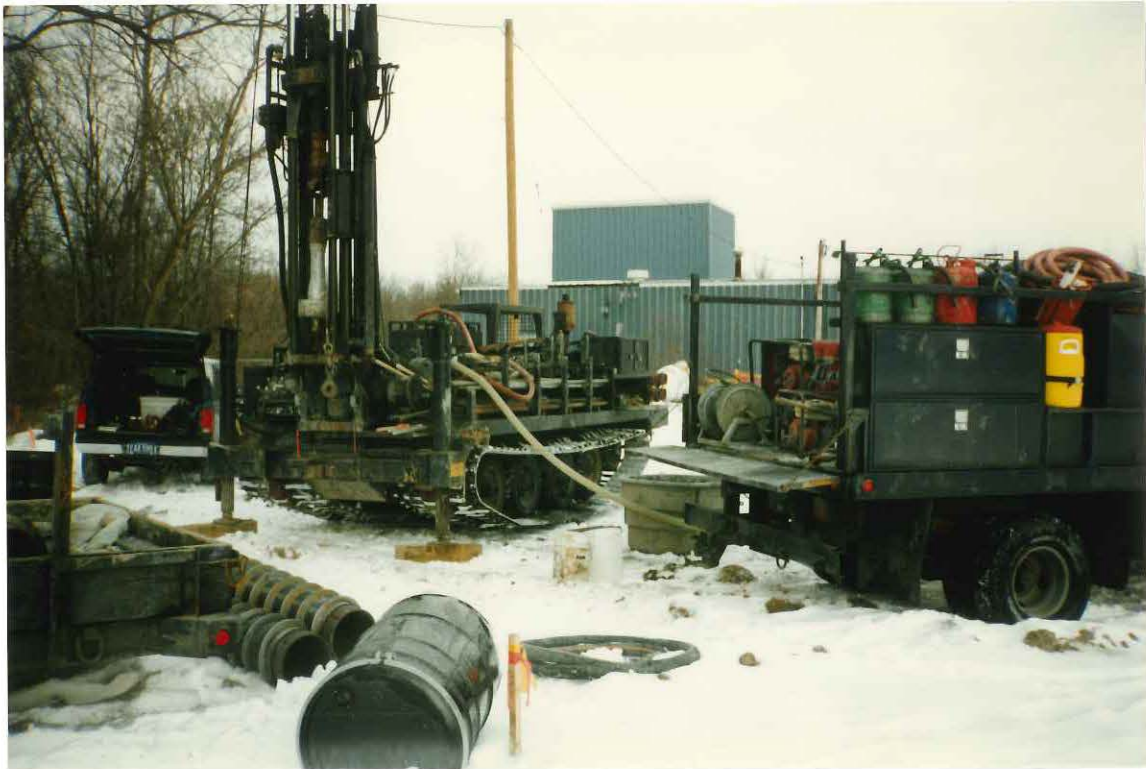
PHOTOGRAPH #28

LOCATION:	Stanley Tools, Fowlerville, MI
DATE:	1/13/94
TIME:	0919
SUBJECT:	Rig on shallow well MW-B4

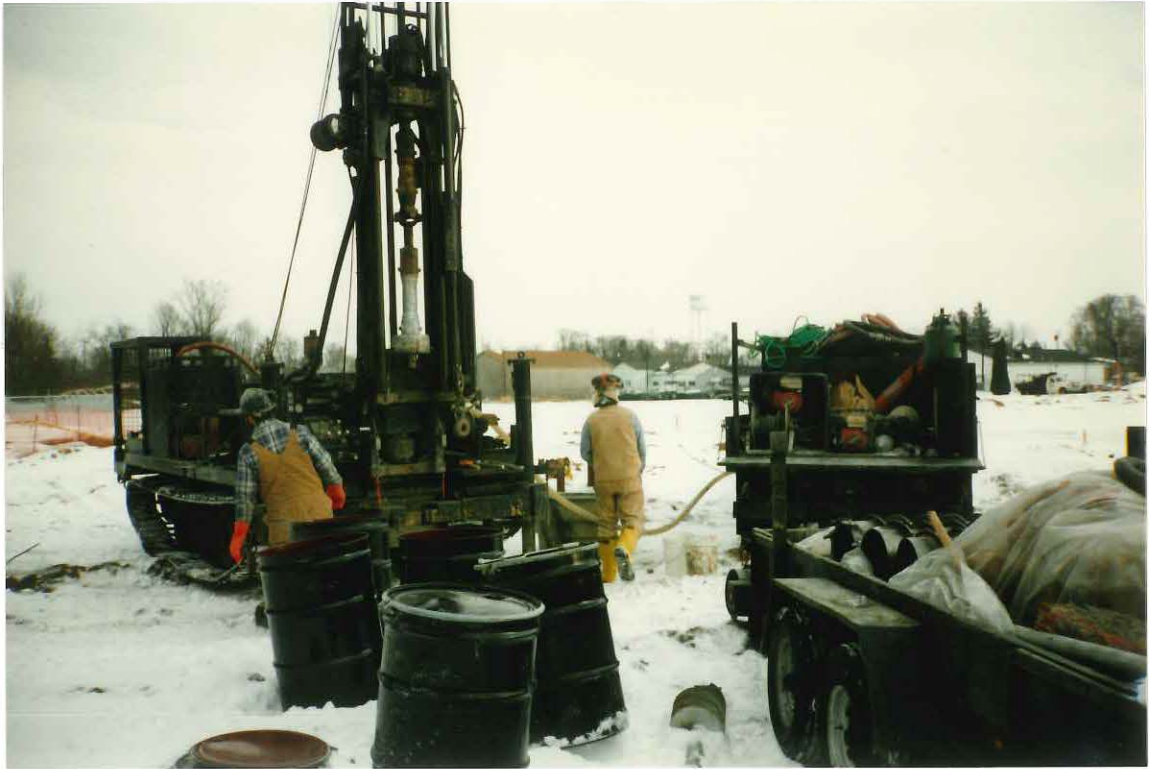
PHOTOGRAPH #29

LOCATION:	Stanley Tools, Fowlerville, MI
DATE:	1/13/94
TIME:	0919
SUBJECT:	Shallow well: MW-B4

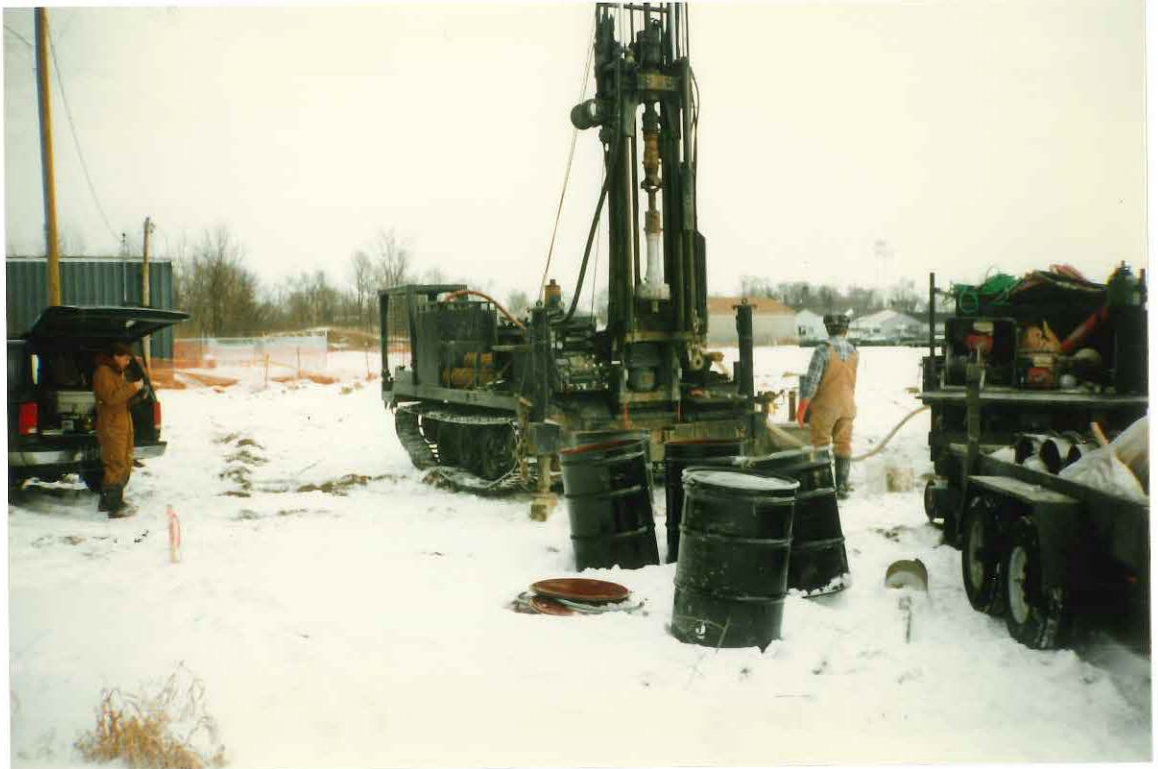
PHOTOGRAPH #30

LOCATION:	Stanley Tools, Fowlerville, MI
DATE:	1/13/94
TIME:	0919
SUBJECT:	Rig on shallow well: MW-B4

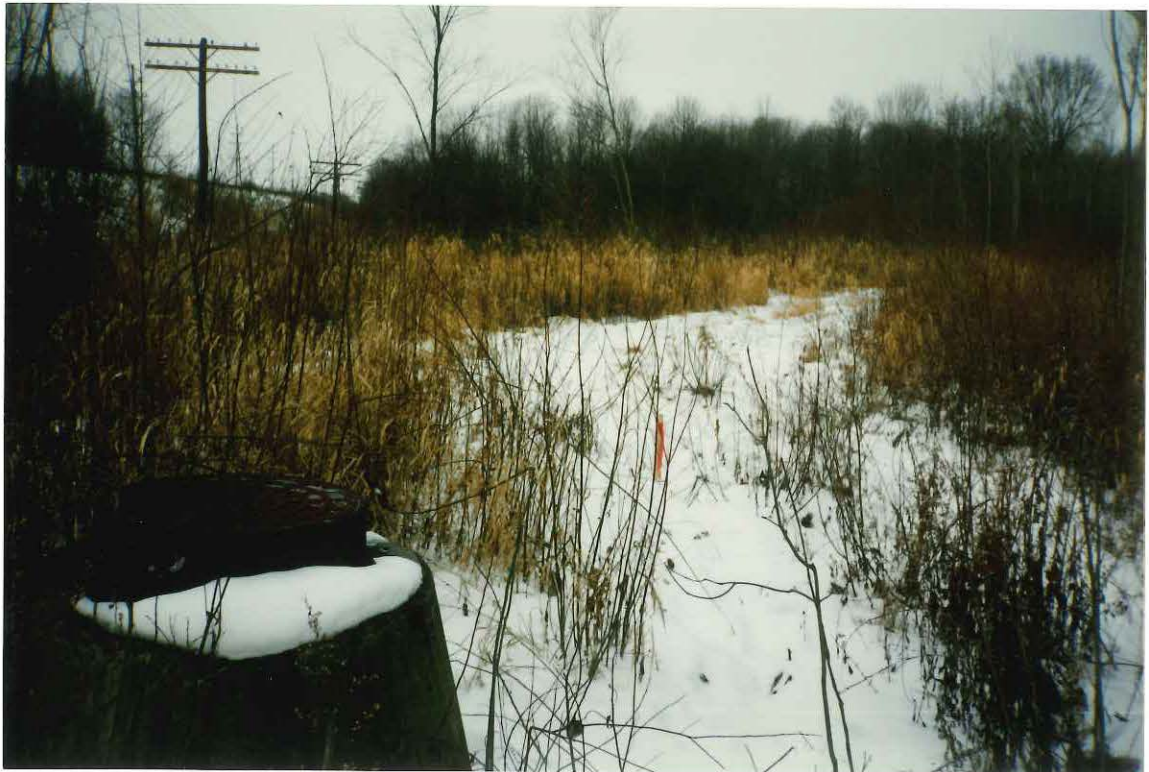
PHOTOGRAPH #31

LOCATION:	Stanley Tools, Fowlerville, MI
DATE:	1/13/94
TIME:	0935
SUBJECT:	Off site well MW-OF3, close to railroad tracks

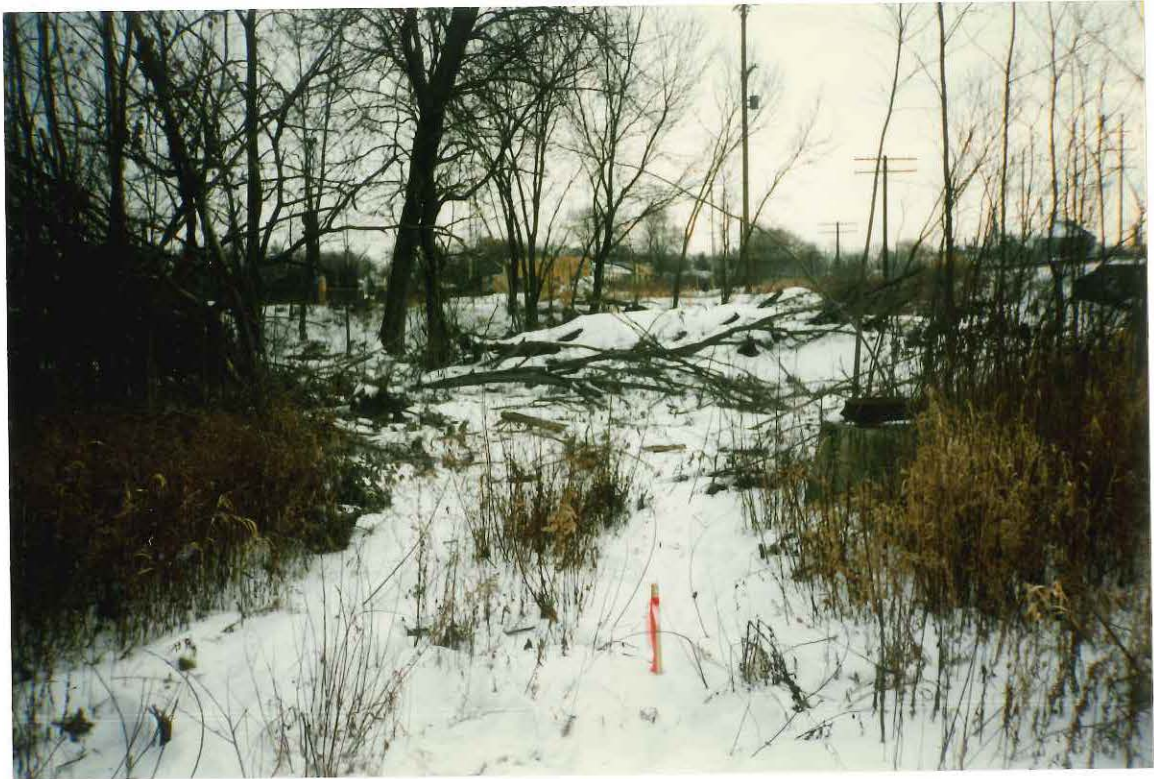
PHOTOGRAPH #32

LOCATION:	Stanley Tools, Fowlerville, MI
DATE:	1/13/94
TIME:	0935
SUBJECT:	Off site well MW-OS3, near railroad tracks

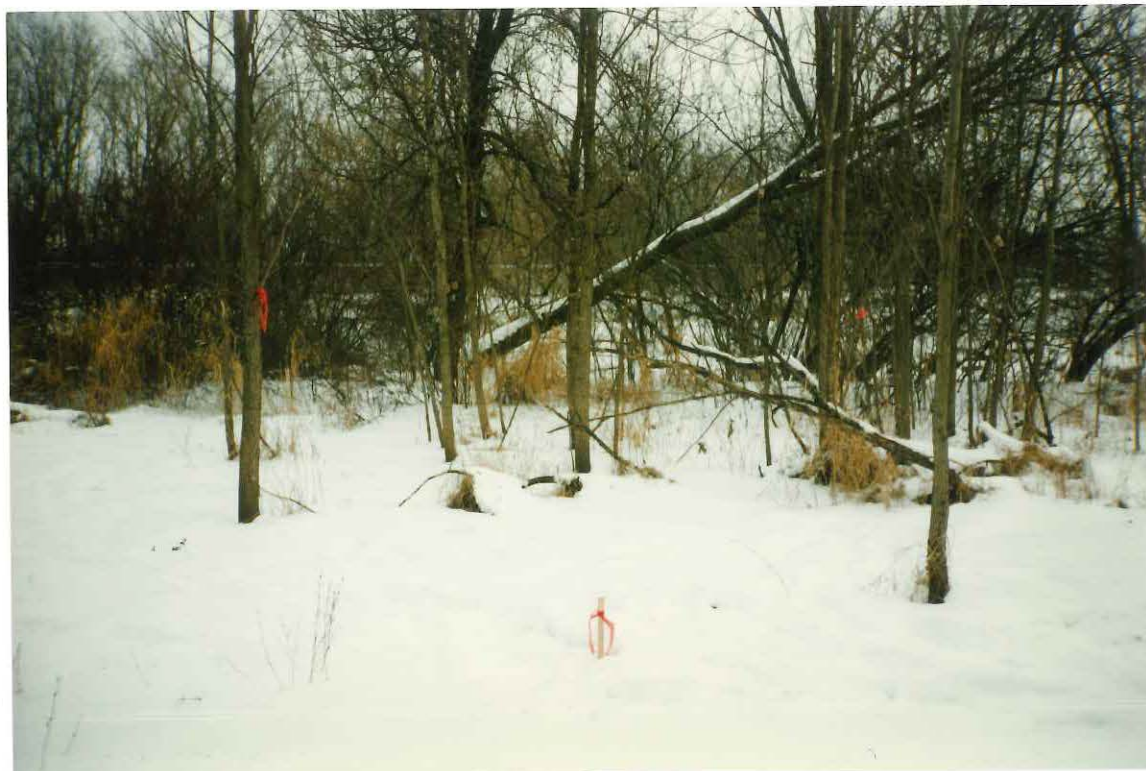
PHOTOGRAPH #33

LOCATION:	Stanley Tools, Fowlerville, MI
DATE:	1/13/94
TIME:	0935
SUBJECT:	Off site well MW-OS1, across from Unit F

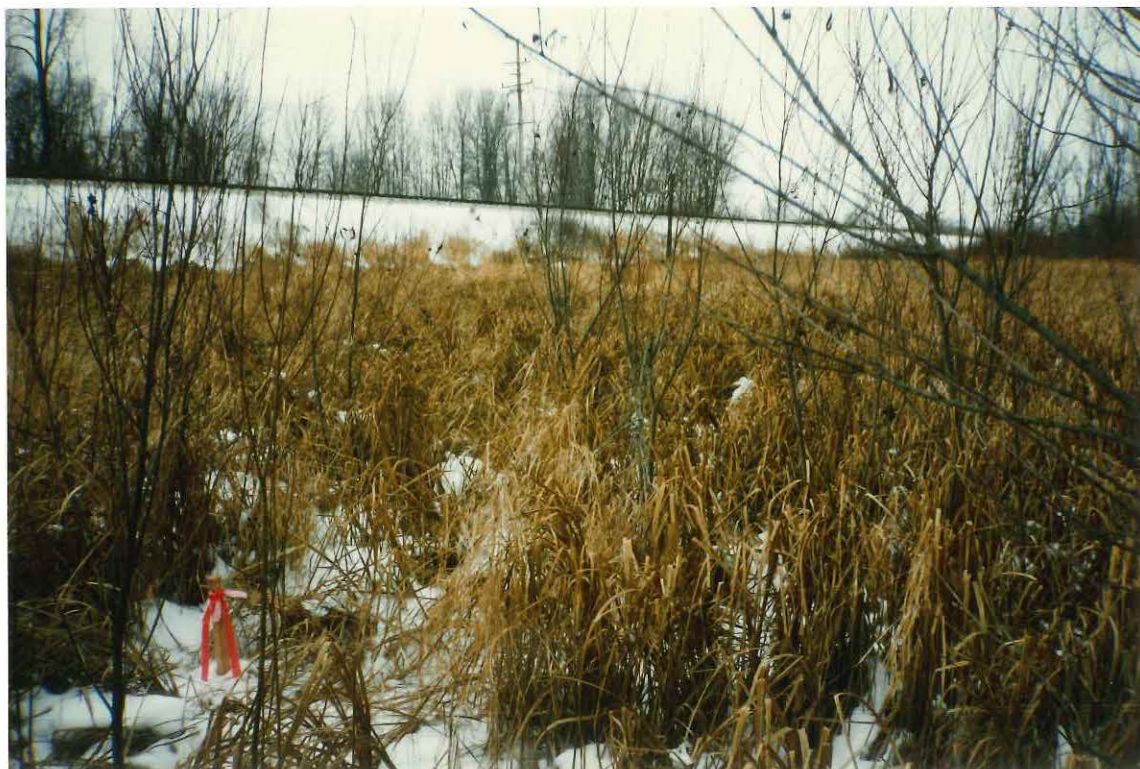
PHOTOGRAPH #34

LOCATION:	Stanley Tools, Fowlerville, MI
DATE:	1/13/94
TIME:	0942
SUBJECT:	Off site well MW-OS2
